[Docket No. 2001-SW-53-AD; Amendment 39-13079; AD 2003-05-03]

Airworthiness Directives; Bell Helicopter Textron Canada Model 407 Helicopters

2003-05-03 Bell Helicopter Textron Canada: Amendment 39-13079. Docket No. 2001-SW-53-AD. Supersedes AD 2000-06-10, Docket No. 99-SW-75-AD, Amendment 39-11651.

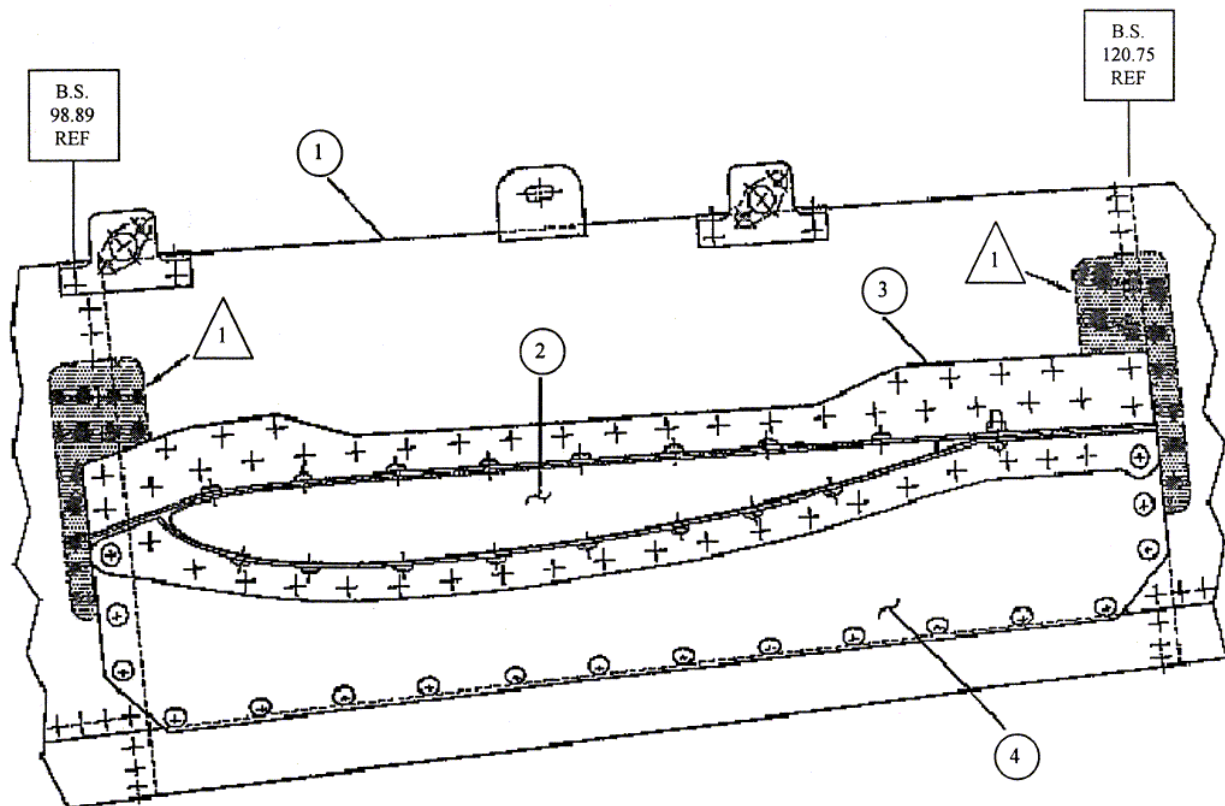
Figure 1. Preflight Check of the Tailboom

SUMMARY: This amendment adopts a new airworthiness directive (AD) for the specified Bell Helicopter Textron Canada (Bell) model helicopters that requires preflight checking and repetitively inspecting for a crack in certain tailbooms that have not been redesigned and replacing the tailboom if a crack is found; modifying and re-identifying certain tailbooms and installing an improved horizontal stabilizer assembly; and assigning a 5,000 hour time-in-service (TIS) life limit. This amendment is prompted by cracking discovered in other areas of certain tailbooms and introduction of a redesigned tailboom with a chemically milled skin, which does not require the current inspections. The actions specified by this AD are intended to prevent separation of the tailboom and subsequent loss of control of the helicopter.

△ 1 Examine these areas for cracks on left side of tailboom only.

Applicable tailboom	Compliance time	Actions	In accordance with
(a) Tailboom, P/N 407-030-801-101 and -105, that have not been modified in accordance with Bell ASB 407-01-048, Revision B, dated April 25, 2002.	Before the first flight of each day	Visually check the tailboom for cracks. An owner/operator (pilot) holding at least a private pilot certificate may perform the visual check required by this paragraph, but must enter compliance with this paragraph into the helicopter records in accordance with 14 CFR 43.11 and 91.417(a)(2)(v).	Figure 1 of this AD.

(f) All applicable part-numbered tailbooms.	Before further flight	If a crack is found, replace the tailboom.	The applicable maintenance manual.
